INVESTIGATION OF STRESS CORROSION CRACKING OF TITANIUM ALLOYS

Semi-Annual Progress Report No. 6

December 1, 1968 through May 31, 1969

E. G. Haney and W. R. Wearmouth

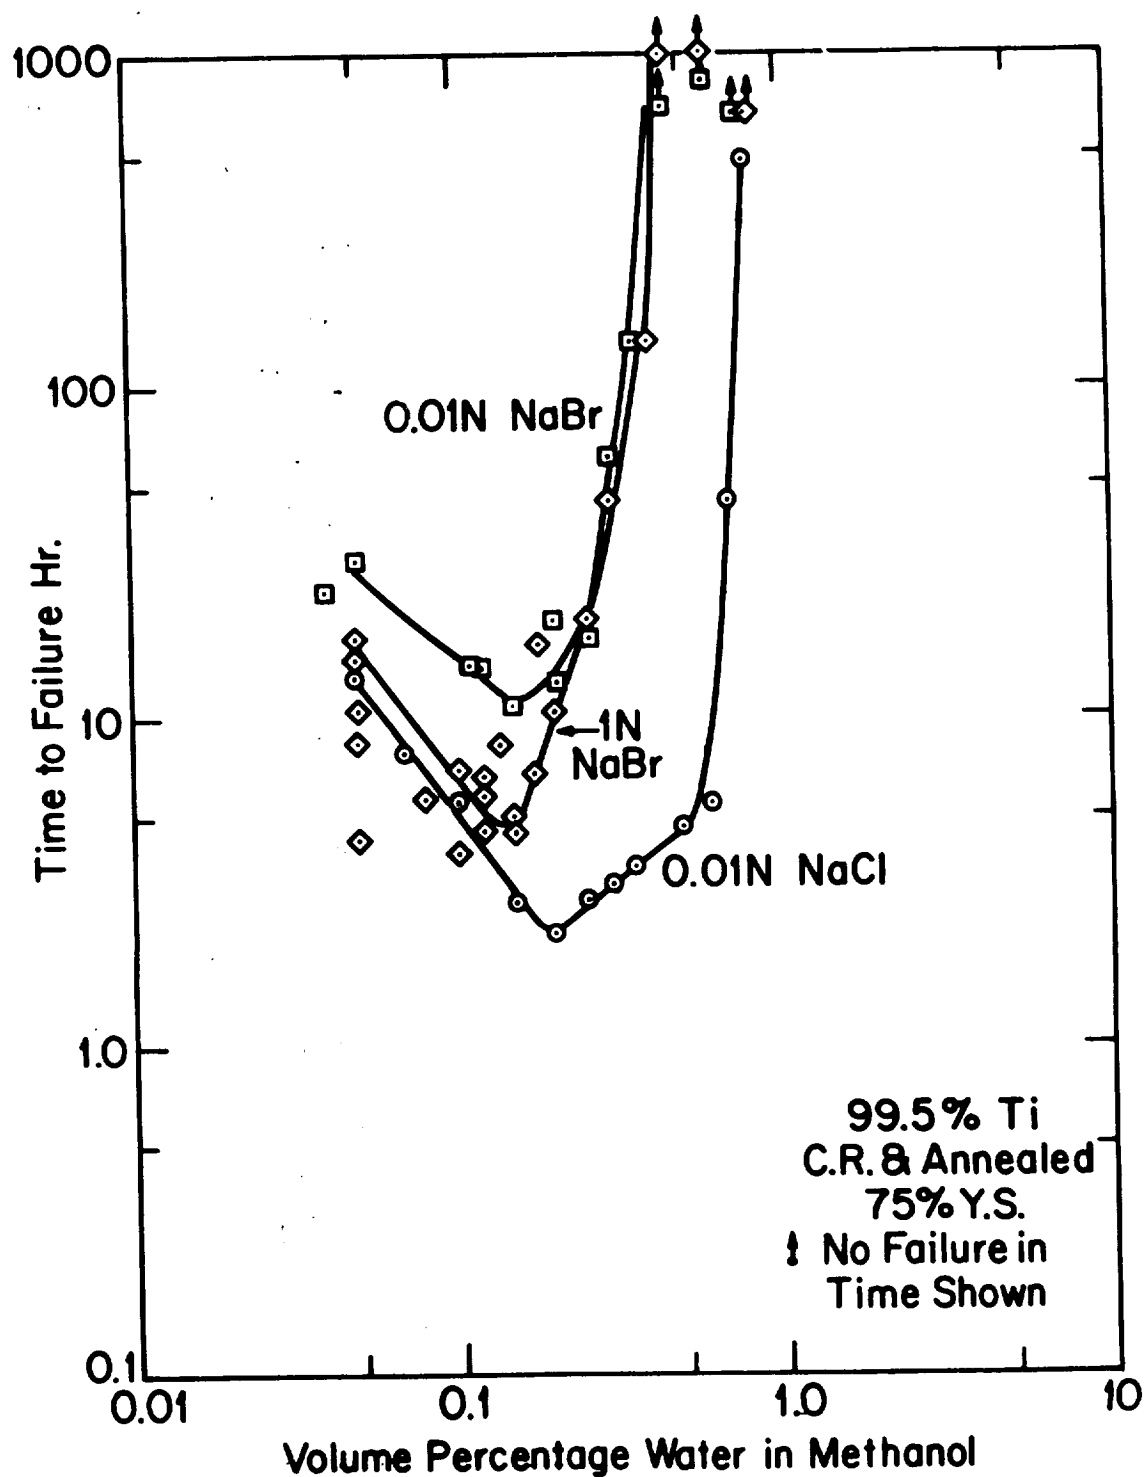
FIGURE 1. Effect of NaBr, NaCl and water content on time to failure.

Work on the effect of low halide concentrations on the cracking susceptibility of 99.5 Ti has been extended to NaBr and NaI, and the results are shown in Figures 1 and 2. Figure 1 shows the time to failure versus volume percentage water in methanol for methanolic solutions containing

1N and 10^{-2} N NaBr. Also shown is the time to failure curve for specimens in methanolic solutions containing 10^{-2} N NaCl. Figure 2 shows the electrode potential values recorded in solutions containing varying concentrations of NaBr and NaI. Similarly to solutions containing NaCl, the NaBr containing solutions show a typical minimum with failure times first decreasing then increasing sharply with increasing amounts of water. Also, as the NaBr concentration is reduced, the times to failure are correspondingly increased. For bromide concentrations less than 10^{-2} N NaBr, the specimens consistently broke in contact with the polyethylene bottle holding the solution around the specimen, producing widely scattered results. At the present time, the reason for the occurrence of such contact breaks is not known. However, on measuring the electrode potentials of specimens in solutions containing lower concentrations of NaBr, Figure 2, it can be seen that the results are very similar to those in solutions containing low concentrations of HCl⁽¹⁾. The electrode potentials in solutions containing no NaBr are also shown. The results for solutions containing 1N, 10^{-2} N and 10^{-3} N NaBr are very similar to those observed for titanium alloys which fail in methanol-water-HCl environments; i.e., low values of electrode potentials at the lowest water concentrations followed by a sharp increase to more noble values as water is added. However, the curves for 10^{-4} N NaBr and no added NaBr are characterized by no sharp increases in slope except at much higher water contents and more noble values at lower water contents. Taking into consideration the results for HCl⁽¹⁾ it would seem reasonable to assume that a limit will also exist for the concentration of NaBr in methanolic solutions below which no failures will occur and possibly this limit may be higher than the limit for

HCl. This would then help collaborate a film pitting mechanism of crack initiation as bromide ions are weaker pitting agents than chloride ions.

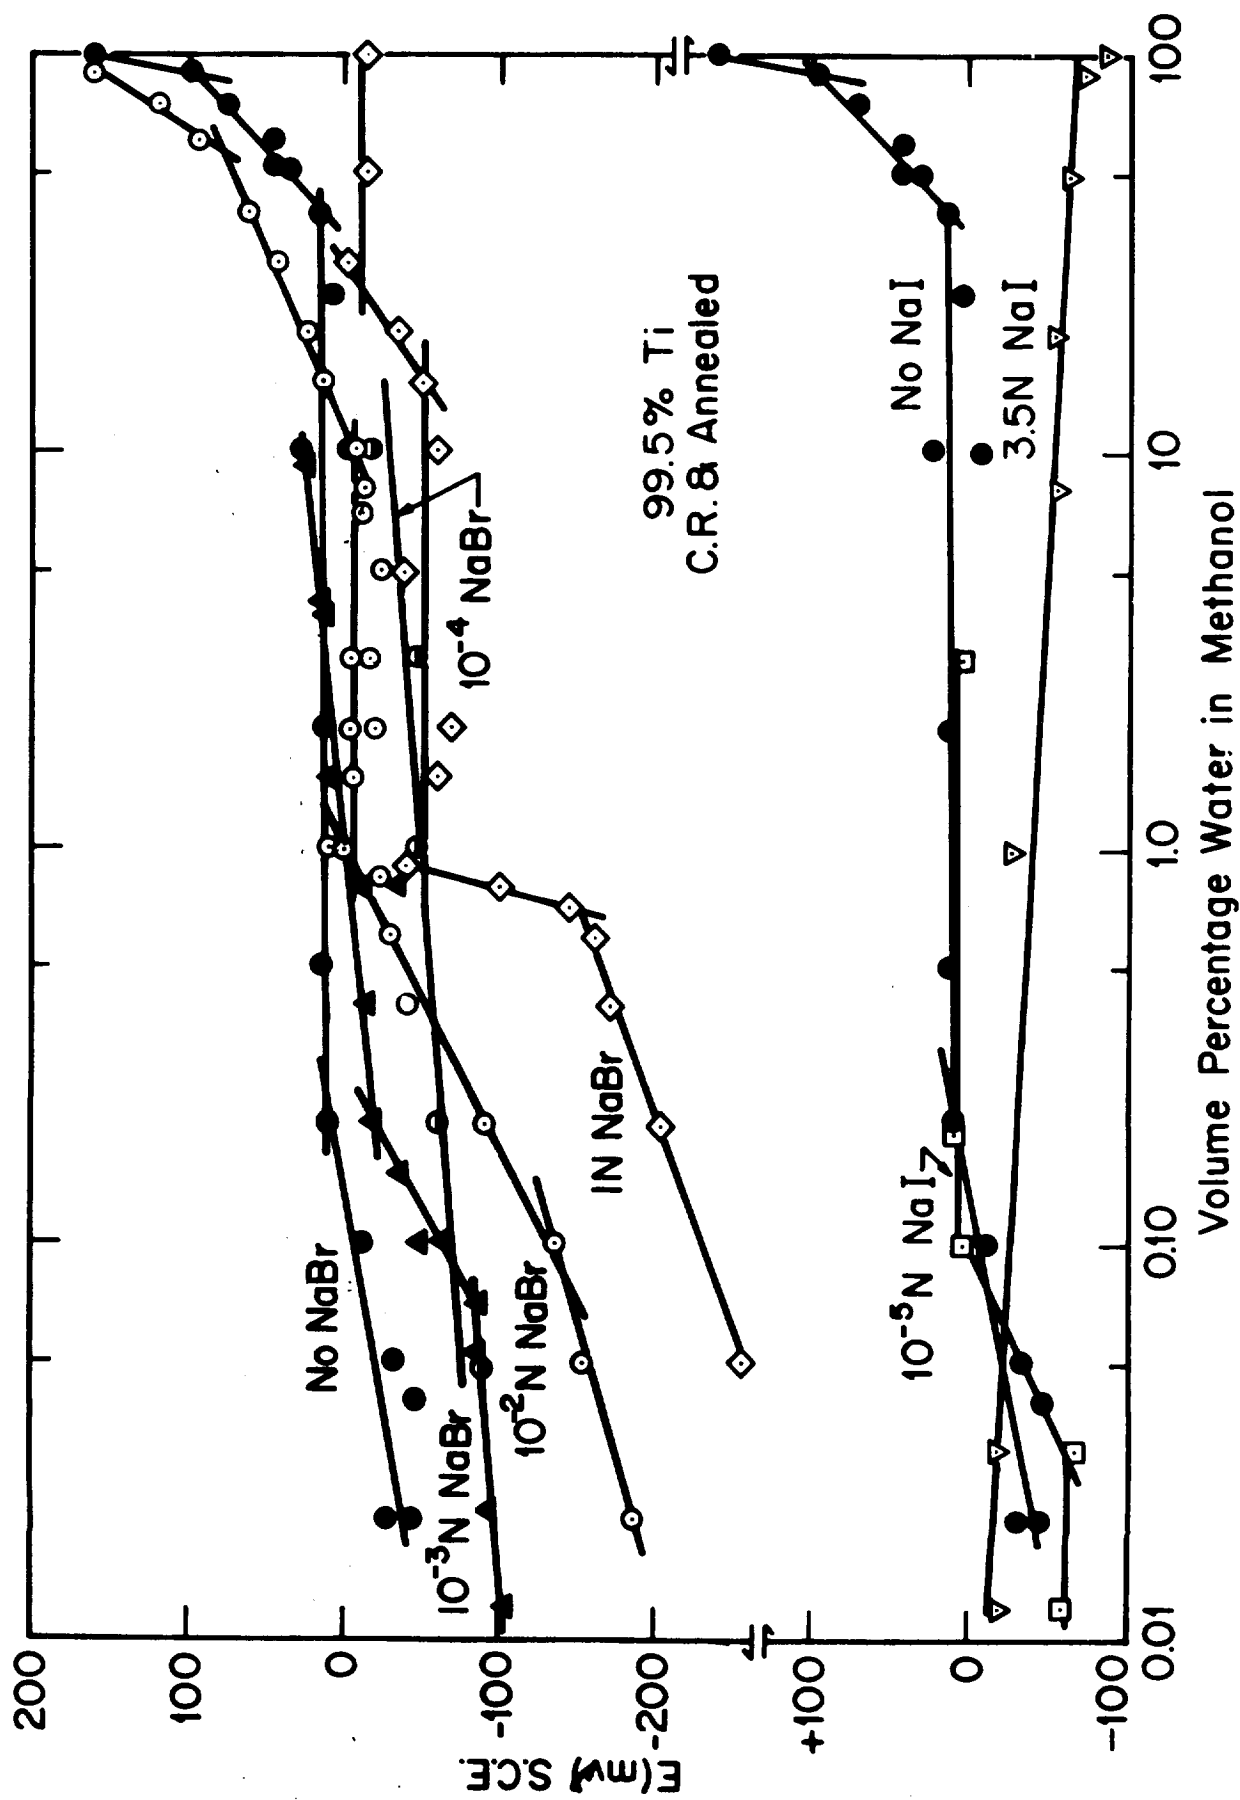
FIGURE 2. One hour electrode potential values as a function of NaBr, NaI and water content.

In methanolic solutions containing varying concentrations of NaI no failures of 99.5 Ti were recorded, and Table IV shows the tensile properties of specimens exposed to such solutions under 75% Y.S. for varying times. It is evident that no deterioration has occurred in the tensile properties indicating that no corrosive attack of the metal has taken place. The electrode potential values in solutions containing 3.5N NaI and 10^{-5} N NaI are shown in Figure 2 and are characterized by no sharp increases in potential as the water content is increased, and consistently show values more noble than -100mV (S.C.E.).

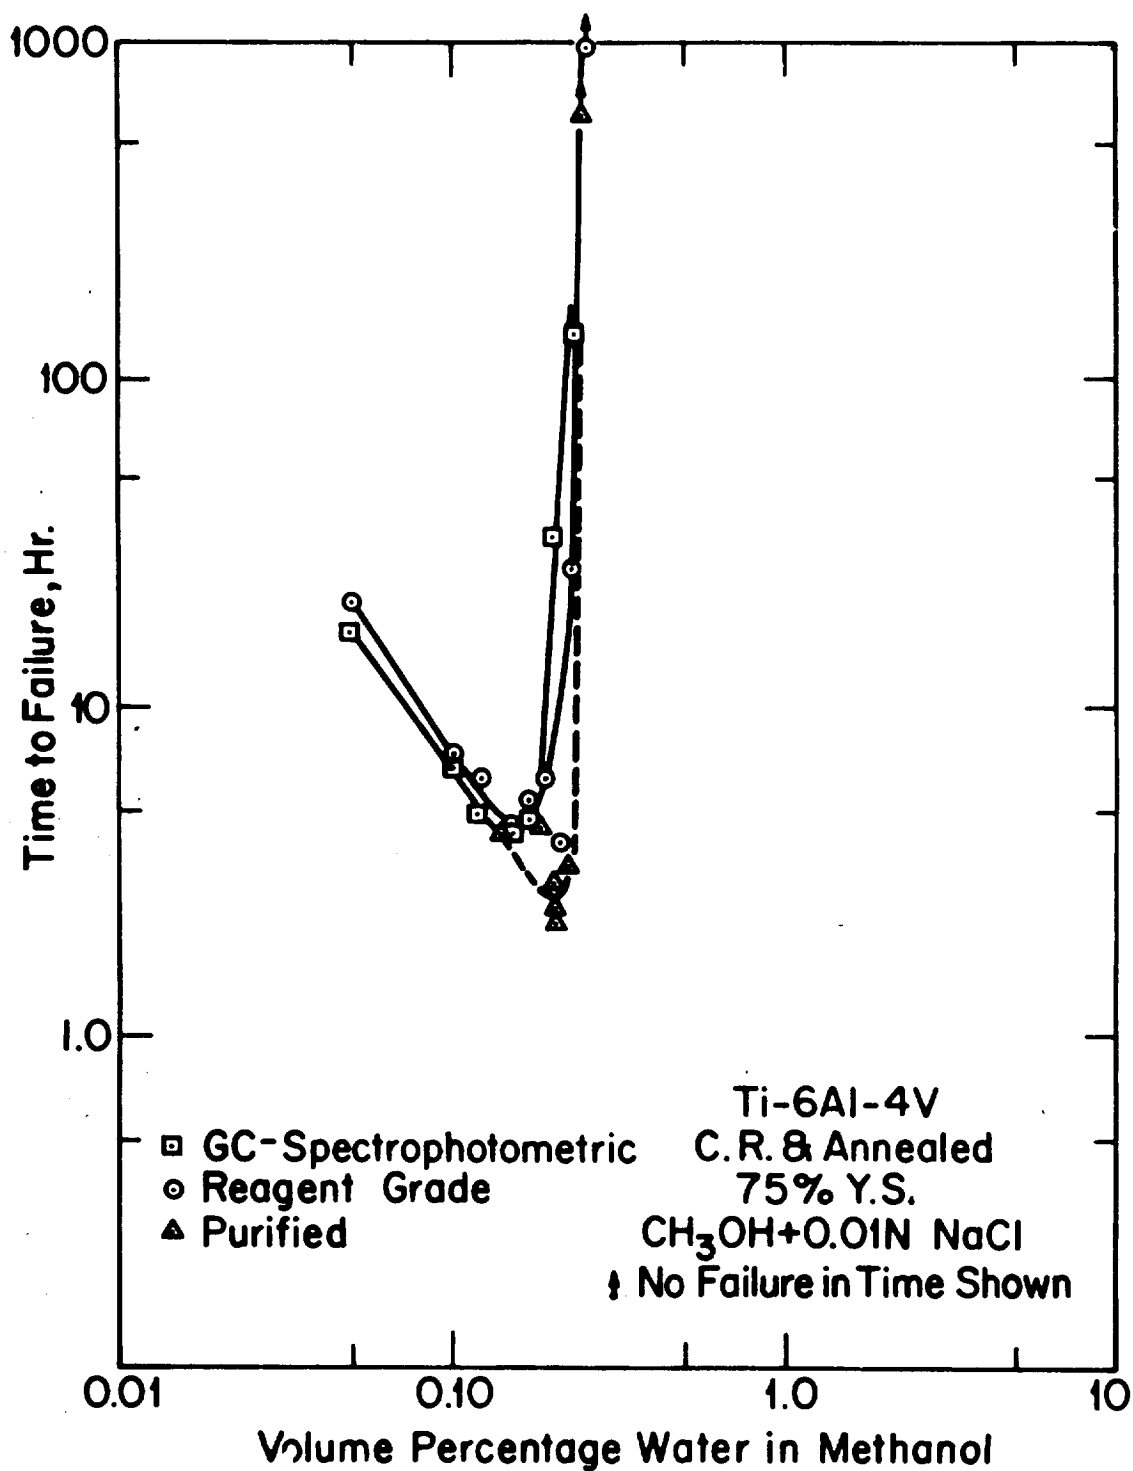
FIGURE 3. Effect of methanol purity on time to failure.

As part of the continuing investigation into the effect of impurities in solution on the cracking characteristics, three different grades of alcohol were used in making up the testing solutions, as explained in the section, "Materials and Procedures". Figure 3 shows the results obtained for Ti-6Al-4V alloy in solutions containing 10^{-2} N NaCl, as a function of water content. Apparently in the spectrophotometric purity methanolic solutions, slightly less water is necessary to inhibit the cracking process, and the times to failure at the minimum are slightly longer, otherwise there is not much difference among the three methanols just as the gas chromatography analysis indicated. On attempting equivalent experiments using Ti-13V-11Cr-3Al, an unusually large amount of scatter was recorded in the times to failure, particularly in the solutions made with the lower purity methanol. Again, however, the trend seemed to be followed that the higher the purity of the methanol, the less water is needed to prevent failure.

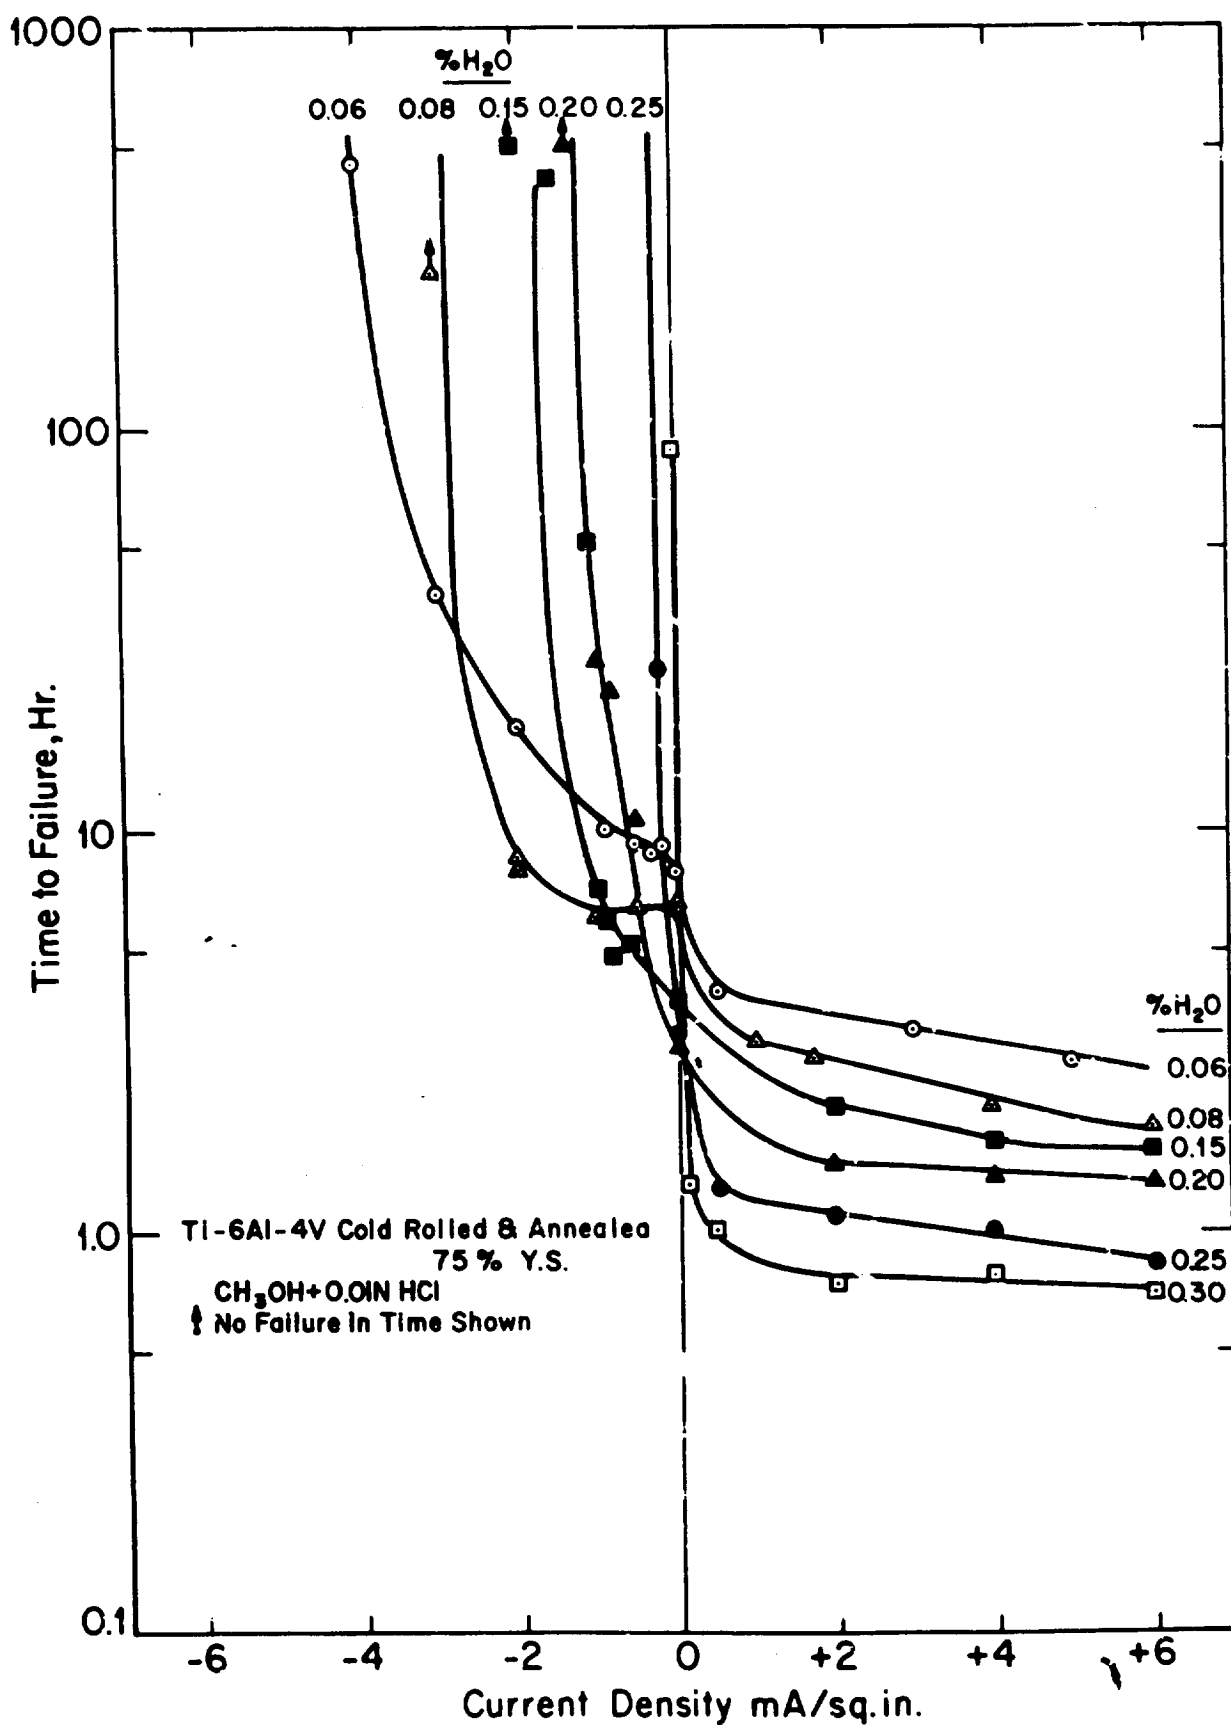
FIGURE 4. Effect of anodic and cathodic polarization on time to failure.

Figure 4 shows the results for solutions containing $10^{-2}N$ HCl as a function of water content. The water carry over from the HCl is 0.05%, so the minimum limit for the water content was 0.06% (0.01% from the methanol). This work showed that cracking did indeed occur under cathodic currents, the cathodic current density required for the prevention of cracking being a direct function of the water content. Thus the lower the water content of the solution, the higher is the cathodic current density needed to prevent failure. However, on the anodic side of the current density abscissa, the higher the water content, the greater is the susceptibility to failure.

Under conditions of zero applied current, the amount of water needed for inhibition of cracking is approximately 0.35%, so to see whether the times to failure would be progressively decreased as the water content was increased, the behavior under an anodic current density of 4 mA/in^2 was investigated as a function of water content. Figure 5 shows the results obtained together with equivalent results under zero applied current conditions, plotting time

Taking into account the work by Scully^(3,4), it would seem reasonable to suggest the following as a possible explanation for the results in Figures 4 and 6, assuming in this instance that hydrogen is a necessary activating agent for the cracking mechanism. In the NaCl containing, slightly acid solutions, the application of a cathodic current sharply increases the ratio $\text{OH}^-:\text{Cl}^-$ at the crack tip resulting in a stable barrier film which restricts the entry of hydrogen into the metal. Evidently, in solutions where this ratio is initially lower; i.e., 0.1N NaCl cf 10^{-2} N NaCl, cracking is still possible under very small cathodic current densities but only then when the water content is very low. However, in the very low pH solutions containing 10^{-2} N HCl, the film is no longer stable and it is possible for hydrogen to enter the metal. Increasing the percentage of H₂O increases both the $\text{OH}^-:\text{Cl}^-$ ratio and the pH although the former effect probably exerts the biggest influence in requiring a smaller cathodic current for prevention of cracking. In solutions containing more than 0.25% H₂O, even though the pH is only 0.3, the $\text{OH}^-:\text{Cl}^-$ ratio is sufficiently high to maintain an effective film barrier. The complete protection afforded by the surface

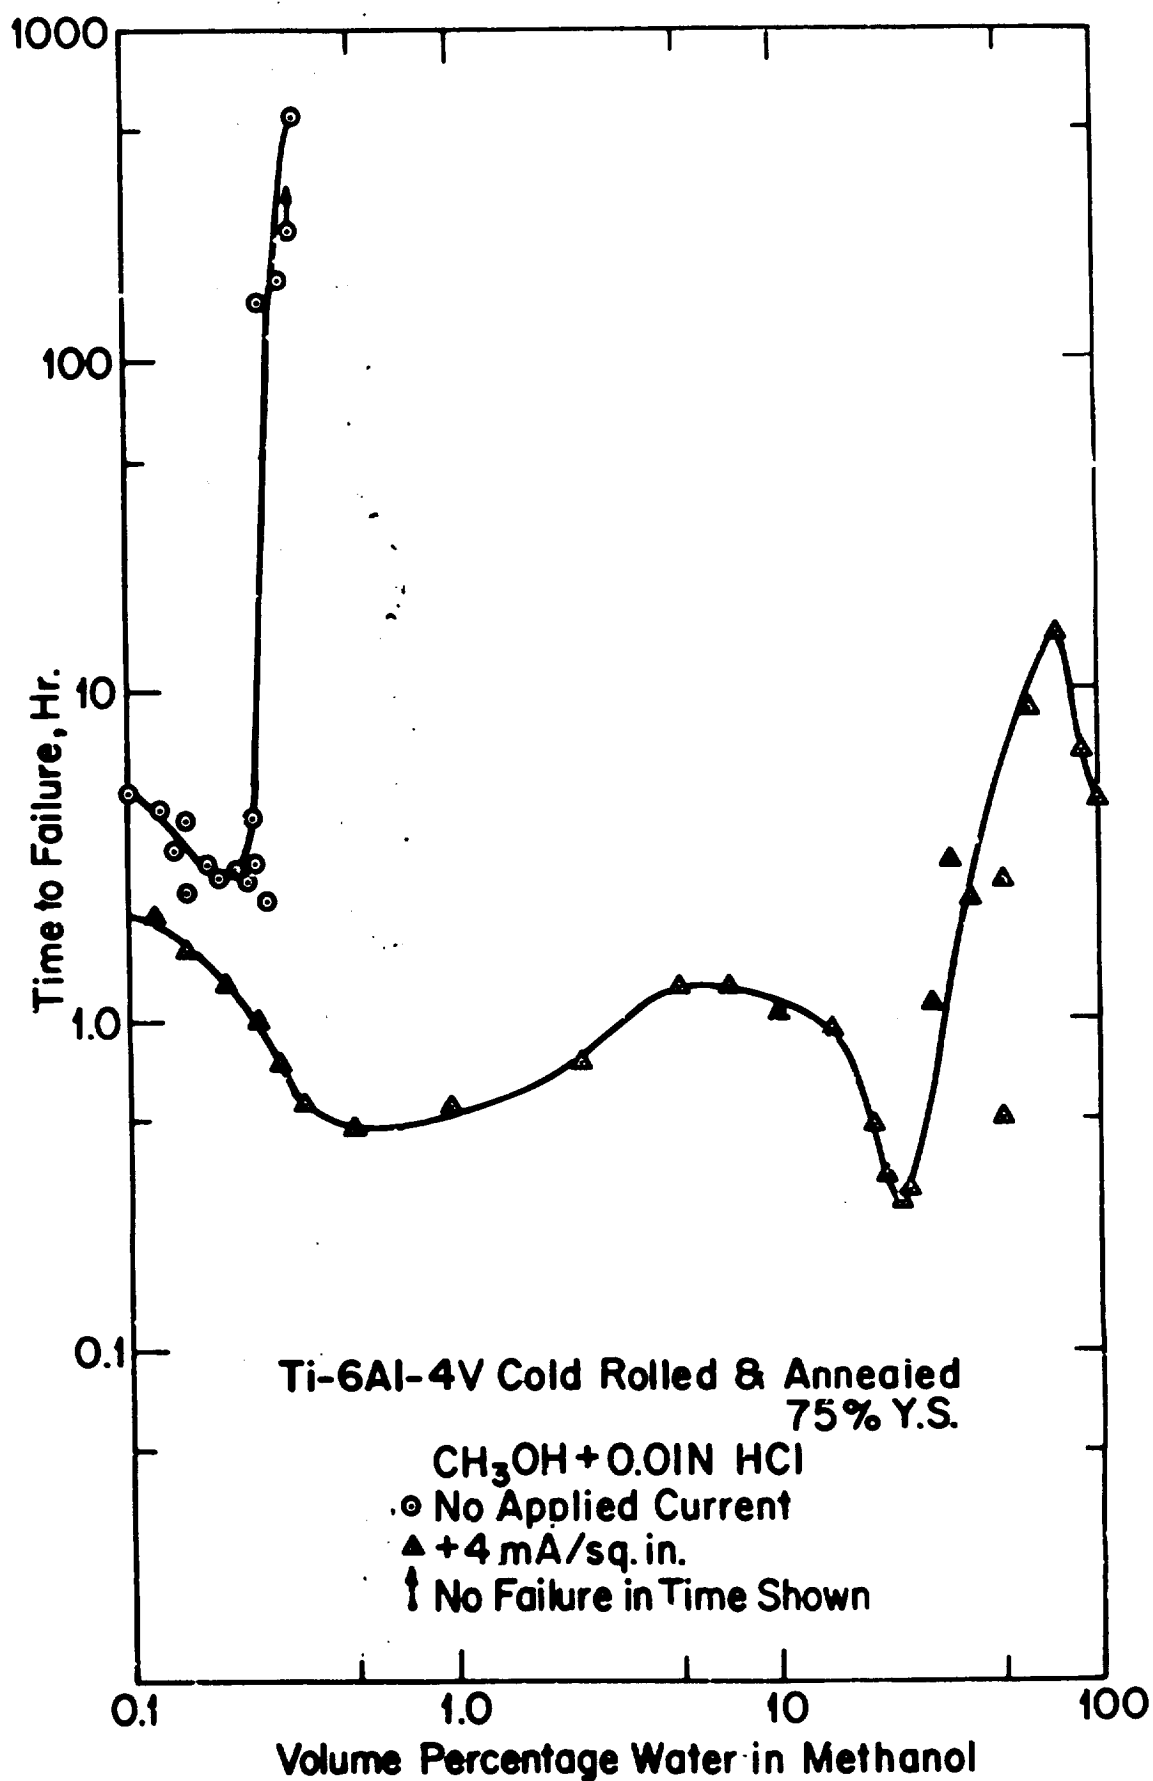
FIGURE 5. Effect of water content on time to failure under anodic polarization.

to failure versus volume percentage water in methanol. Under anodic polarization the range of failure can be extended to solutions containing 100% H_2O , and it can be readily seen that the time to failure is not a simple function of water content. Visual and microscopical examination of failed specimens revealed the initiation of a pitting mechanism at approximately 20-25% H_2O , and indeed the specimen failed at 40% H_2O had about 10 perforations averaging about 1mm diameter. As the water content is further increased, the pitting becomes increasingly more severe until at 90% H_2O failed specimens are found to contain large edge pits which have consumed approximately half the foil width. In solutions containing 100% H_2O , although the pitting was severe, it was not as severe as in the water solutions containing some methanol. In solutions containing less than approximately 25% H_2O , the density of cracking seemed to be a function of the water content, increasing as the water content increased. However, when macroscopic pitting and perforation occurred, the density of cracking along the gauge length decrease sharply although in the vicinity of the fracture there still remained a high crack density.

An interesting feature of the results shown in Figure 5 was the failure of specimens in solutions containing a minimal amount of methanol and also in aqueous solutions containing $10^{-2}N$ HCl. A metallographic examination of specimens failed in the latter solutions revealed an absence of cracking along the gauge length. However, adjacent to the fracture edge and at the leading edge of the pits cracking was indeed visible, particularly so at the fracture surface. It would, therefore, appear that under the right conditions cracking of Ti-6Al-4V is also possible in aqueous solutions, the nature of the pits being either to act as stress concentrators or to promote a reactive environment within the pits. Scully^(4,5) has also reported cracking of un-notched specimens of Ti-5Al-2.5Sn in aqueous solutions containing 3% NaCl, but only in a specific range of strain rates.

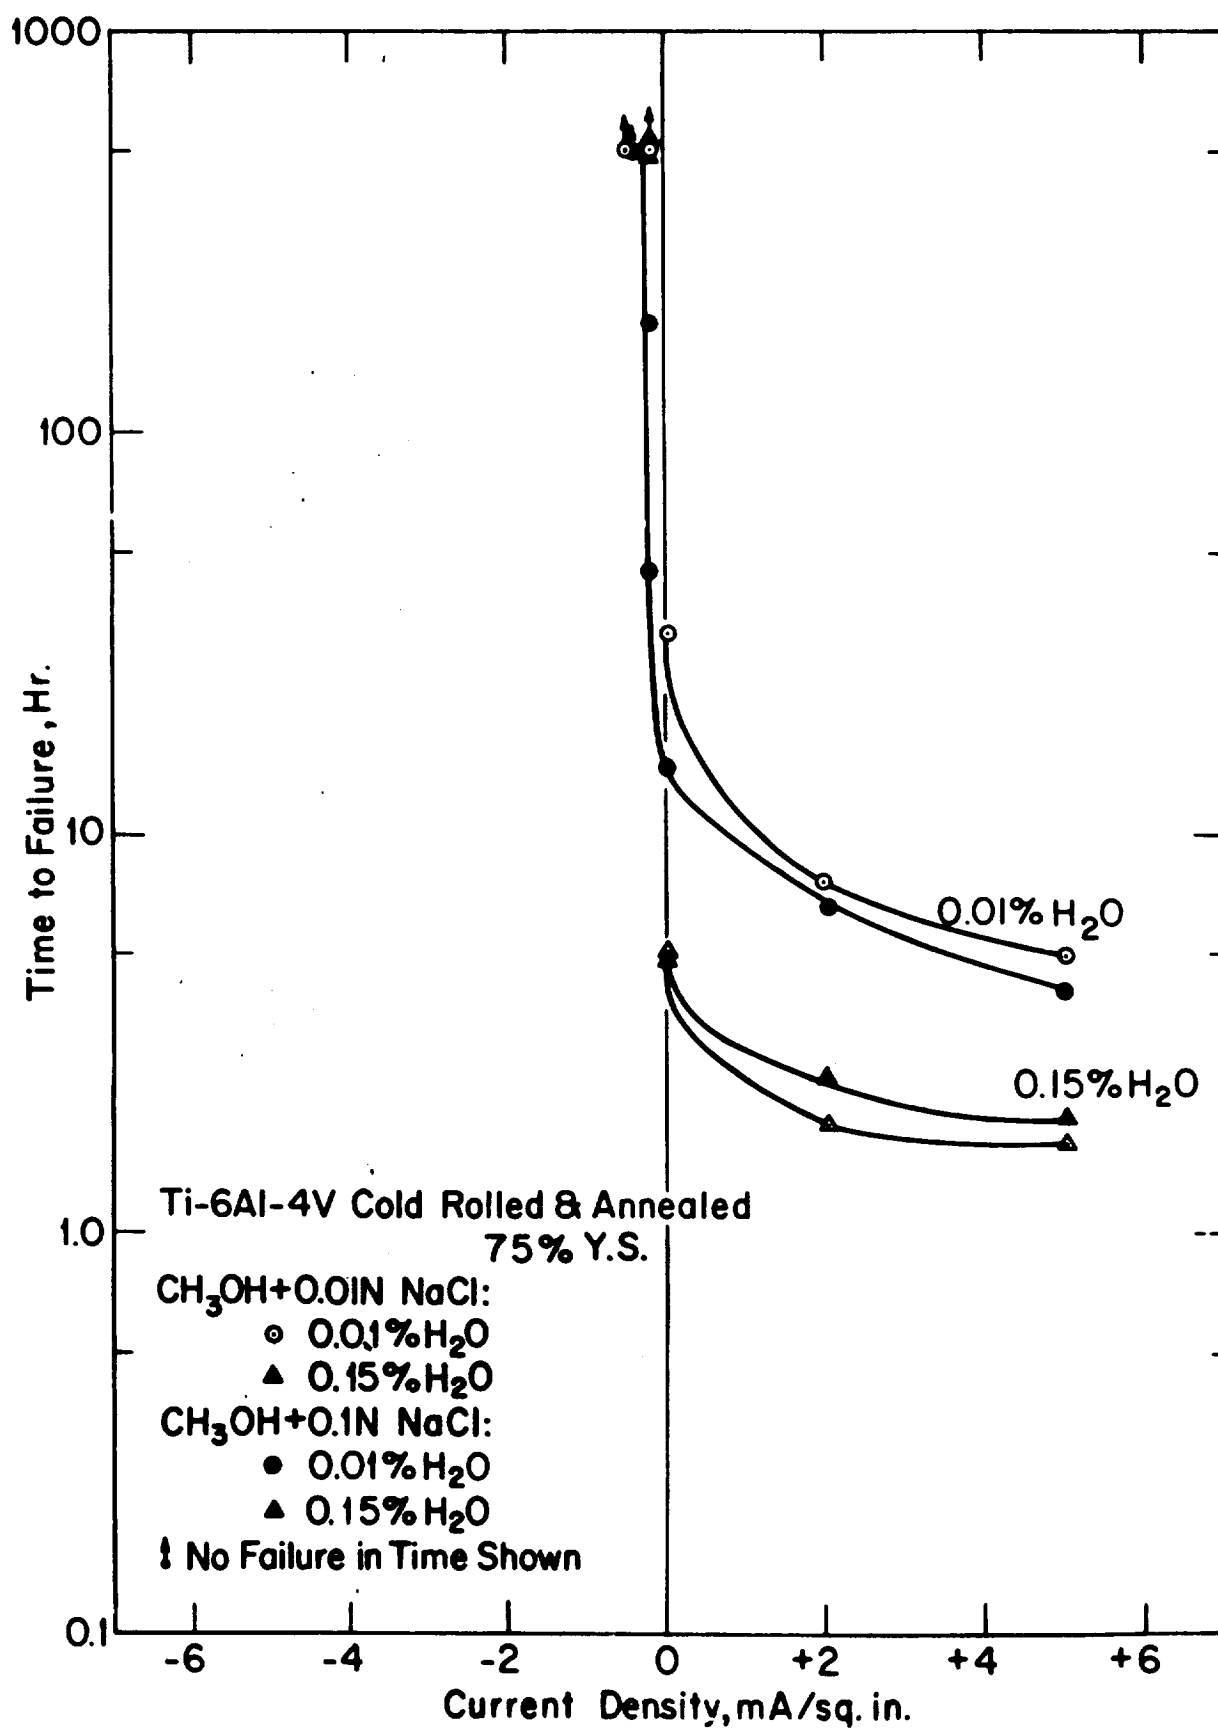
FIGURE 1. Effect of anodic and cathodic polarization on time to failure.

The behavior under the effect of applied currents in methanolic solutions containing NaCl contrasted strongly with that in solutions containing HCl. As can be seen in Figure 6, the effect of anodic currents decreased the times to failure. However, on the cathodic side, even in solutions containing only 0.01% H_2O , breaks were only recorded at -0.2 mA/in^2 and to promote these breaks, the chloride content had to be increased to 0.1N NaCl. This is close to the maximum solubility limit for NaCl in methanol, approximately 0.15N NaCl.

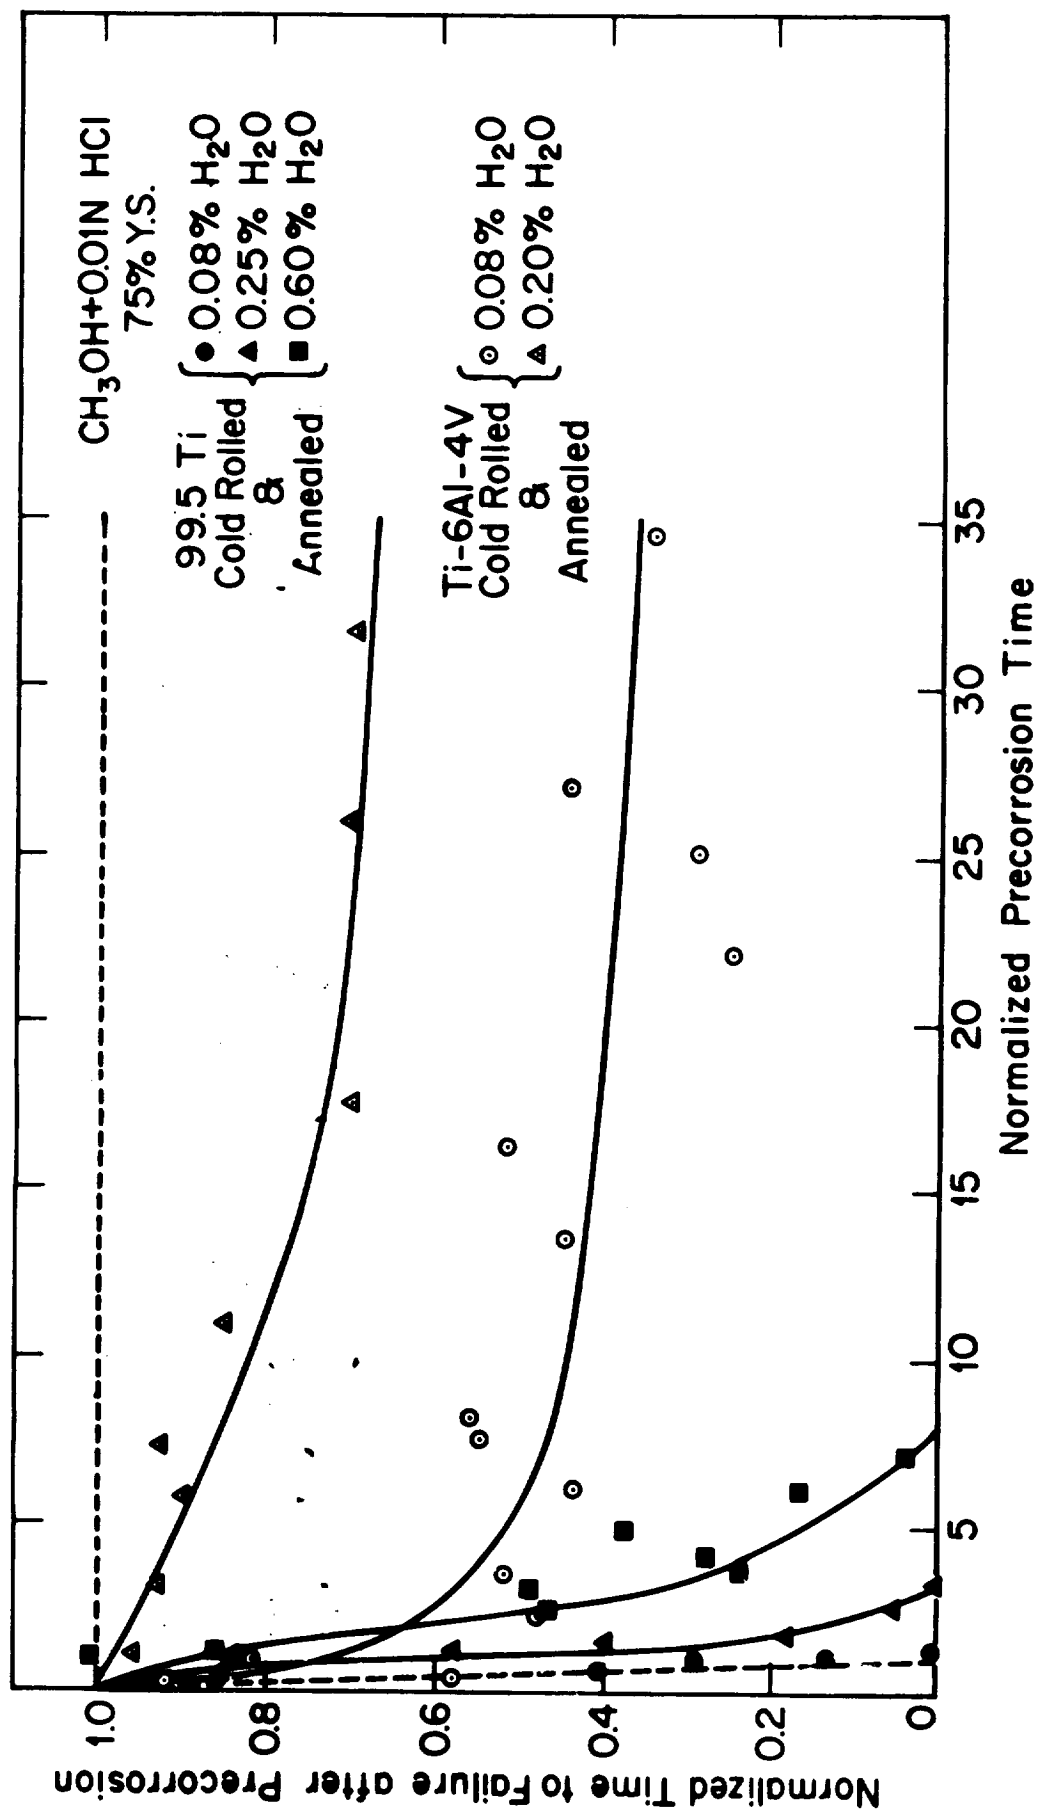
FIGURE 7. Effect of precorrosion on time to failure.

Figure 7 shows the results obtained in this laboratory for specimens of 99.5 Ti and Ti-6Al-4V as a function of water content. The ordinate and abscissa have been normalized by dividing by the normal failure time in each

solution, with the load and solution added simultaneously. If pre-corrosion has no effect on the time to failure, the results would be expected to lie along the broken horizontal line, whereas if the rate of deterioration due to corrosion proceeds independently of the applied stress, the results would be expected to lie along the broken line with a gradient of one. Thus, it should be possible to differentiate between a S.C.C. mechanism and a purely corrosion mechanism.

The results shown in Figure 7 strongly suggest that in the case of 99.5 Ti in the annealed condition, failure results, at least in the low water content solution, from deterioration produced solely by the corrosion reaction. The interpretation of the results produced by the higher water content solutions would seem to be concerned with the inhibiting effect of water on the corrosion reaction. In this instance, the less rapid rate of deterioration would be a direct consequence of the lower reaction kinetics of the corrosion process. It is also likely that the applied stress might accelerate the corrosion reaction to some extent by causing film breakdown by the stress concentration produced at the crack tip.

In the case of the Ti-6Al-4V alloy, the rate of deterioration is far less and it might appear from the shape of the curves that they eventually reach a limit beyond which subsequent corrosion damage does not occur. This would correspond to the situation recorded by Cocks *et al.*⁽⁸⁾ for Ti-6Al-4V in methanol containing 0.8 volume percent of bromine. However, it should be noted that they only plotted results for specimens pre-corroded for times equivalent to three times the normal failure time, and it seems extremely unlikely that for more prolonged times no further deterioration

would occur. In the present work, normalized time to failure values of 0.16 and 0.48 were obtained for normalized pre-corrosion times of 56.2 and 69.0 (not plotted), for Ti-6Al-4V in solutions containing 0.08% and 0.20% H_2O respectively. Thus, there is a continual, though small, effect of pre-corrosion on the failure times as the period of exposure is further increased from that shown in Figure 7.

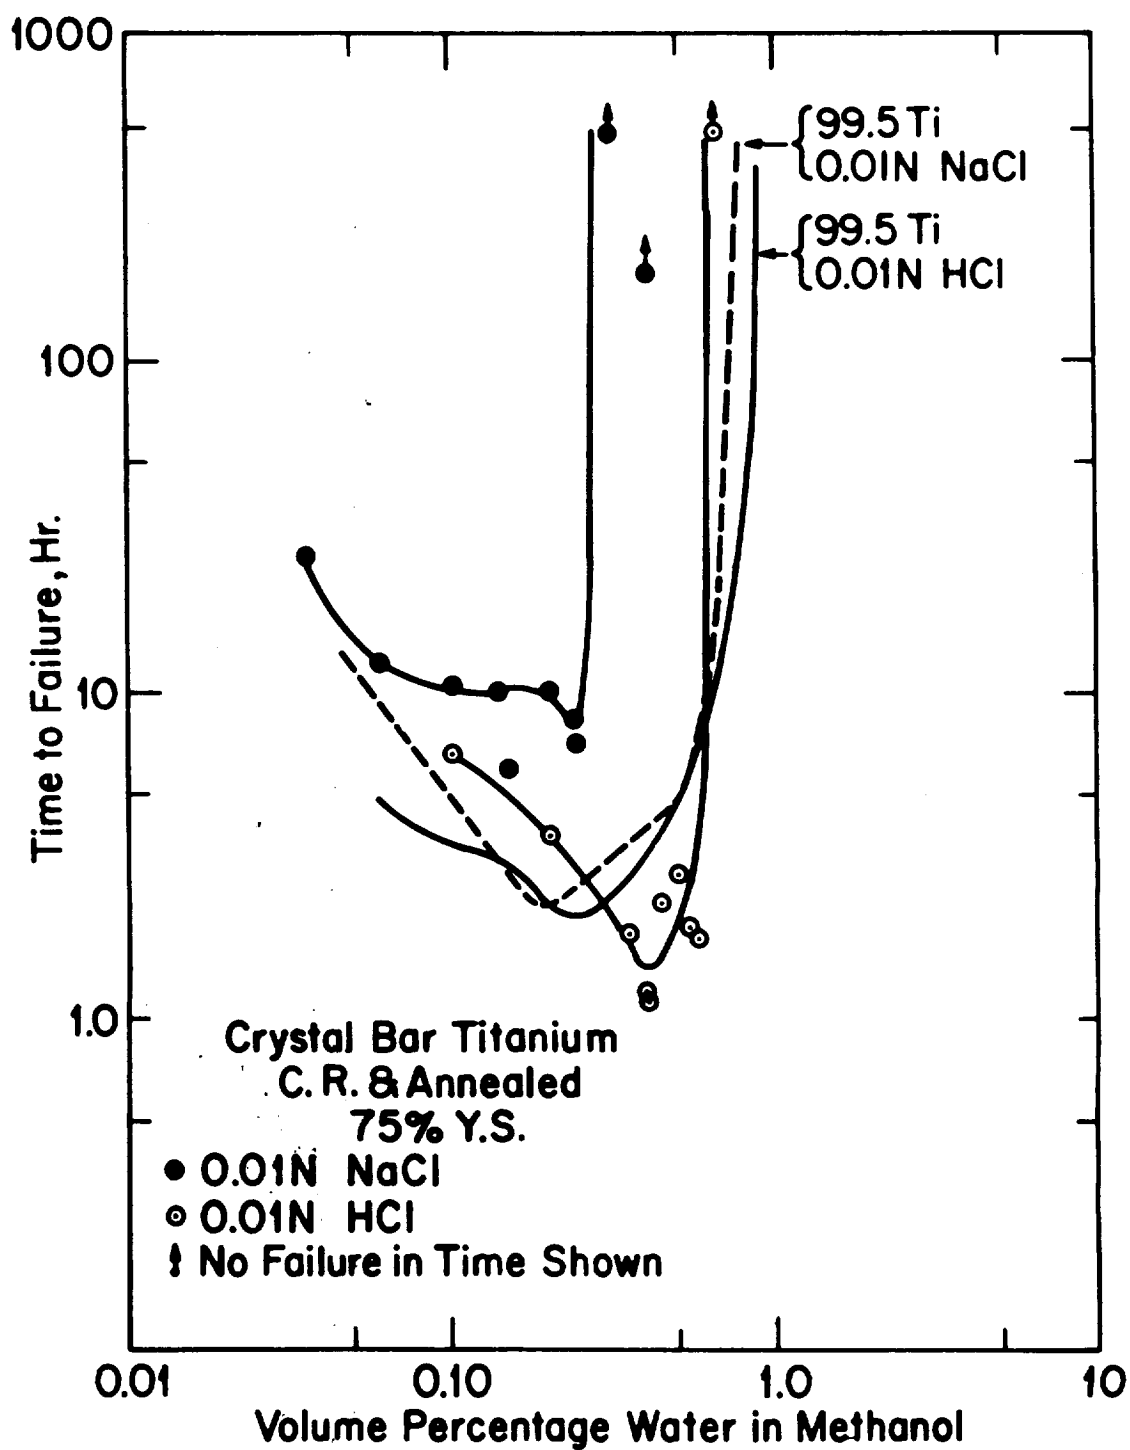
FIGURE 3. Effect of titanium purity and water content on time to failure.

Annealed specimens of the iodide process titanium were found to be no less susceptible to failure in methanolic solutions than annealed specimens of 99.5 Ti. Figure 8 shows the results obtained in solutions containing $10^{-2}N$ HCl and $10^{-2}N$ NaCl, together with curves for 99.5 Ti in similar chloride containing solutions. However, whereas for the 99.5 Ti there is very little difference whether the solution contains NaCl or HCl, this is definitely not the case for the crystal bar titanium. As can be seen, solutions containing HCl lower the failure times by nearly an order of magnitude compared with solutions containing NaCl, and also the water content needed for inhibition of the cracking process is increased from

0.3% to 0.65%. The mode of failure is intergranular as in the 99.5 Ti, and fractographs of the S.C.C. fracture surface reveal no differences between the two grades of titanium (see later section). At the present time, the reason for the enhanced susceptibility in the HCl containing solutions is not known.

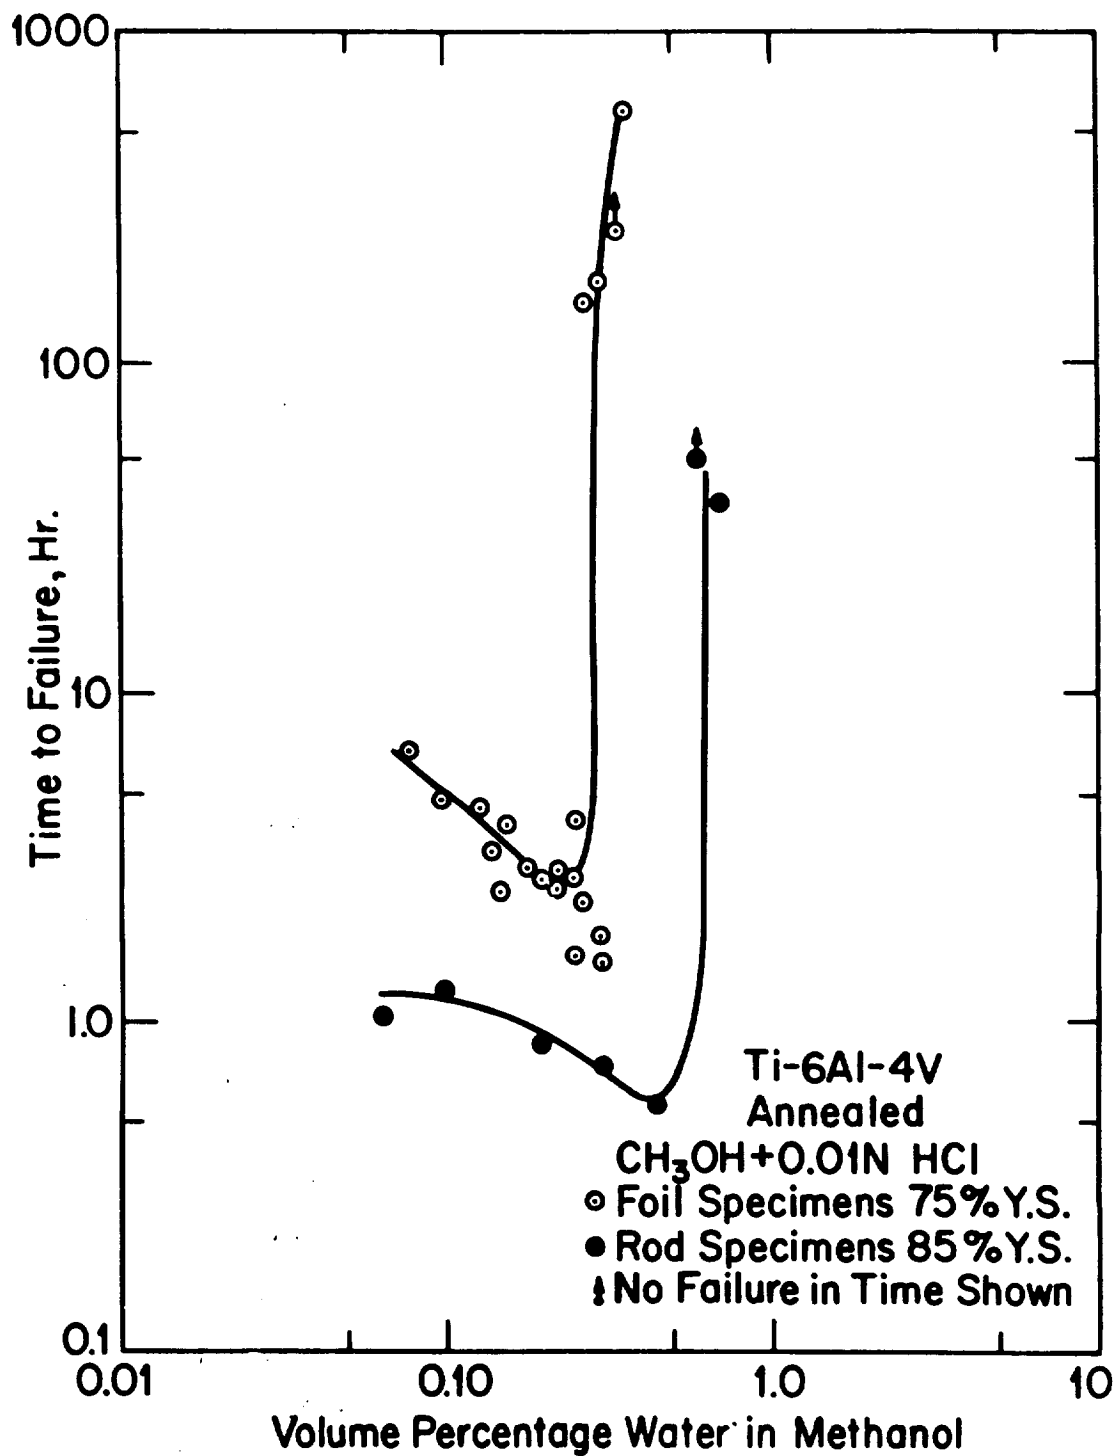
FIGURE 9. Effect of specimen form and water content on time to failure.

Figure 9 shows the results obtained with the rod specimens of Ti-6Al-4V together with similar results obtained with foil specimens of the same nominal composition. It is readily seen that the rod specimens are equally susceptible to failure in methanolic solutions, and in fact under the present set of testing conditions are even more so. Also, the shape of the time to failure curve is similar in that a small amount of water accelerates the cracking process but eventually complete protection is obtained at approximately 0.7% H₂O.

A limited number of rod specimens of the alloy Ti-5Al-5Sn-5Zr were also tested in methanolic solutions and time to failure values of the same order of magnitude as those shown in Figure 9 were recorded. Due to the limited number of specimens, it was not possible to define the shape of the curve of time to failure versus water content. However, there is no reason to believe that it would be markedly different to those shown in Figure 9. The load-time curves were similar in shape to those for Ti-6Al-4V, although during the crack initiation period there was a continual, though small, relaxation in the load, probably due to continual relaxation of the specimen. The fracture surfaces were rough with no macroscopically flat portion of the magnitude found on fractured specimens of Ti-6Al-4V. Also, the only subsidiary cracking occurred in the deformed region adjacent to the main fracture surface.
